TECHNICAL UPDATE

ARCHITECTURAL BRICK DETAILING THAT CAN REDUCE THE SERVICE LIFE OF BRICKS

Introduction

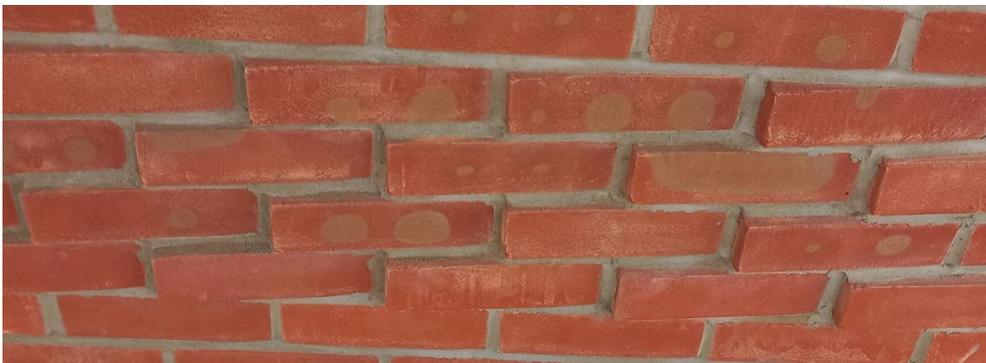
Architectural detailing within brickwork patterns can result in bricks being partly projected out from the face of the wall. Below is an example of a "saw-tooth/wave pattern" where the tops of the bricks project out from the face of the wall. In this particular case, the brick manufacturer confirmed that as result of using this pattern, the lifespan of their brick would be reduced to 30 years from the 60 years anticipated when laid in the traditional manner.

Where the proposed projecting bricks include frogs or perforations, this can have a negative impact upon the integrity and thus durability of the brick, potentially reducing the service life of the brick below the required 60 years as required by our warranty.

In order to ensure that the correct brick is being used for the proposed detailing, the topside exposure of the brick needs to be considered and whether there is a risk of any perforations or frogs becoming exposed. If this is the case then a referral needs to be made to the brick manufacturer so that they can confirm the brick service life will be not less than 60 years. The designer may wish to consider the use of "special-bricks" provided specifically by the manufacturers to create the selected pattern.

For the avoidance of doubt, the brick manufacturer should confirm the expected durability of the product in the proposed use so that it will meet our warranty service life requirement of 60 years.
